GEOLOGIC FEATURES OF THE EARTHQUAKE AT HEBGEN LAKE, MONTANA, AUGUST 17, 1959

BY IRVING J. WITKIND, W. BRADLEY MYERS, JARVIS B. HADLEY,
WARREN HAMILTON, AND GEORGE D. FRASER

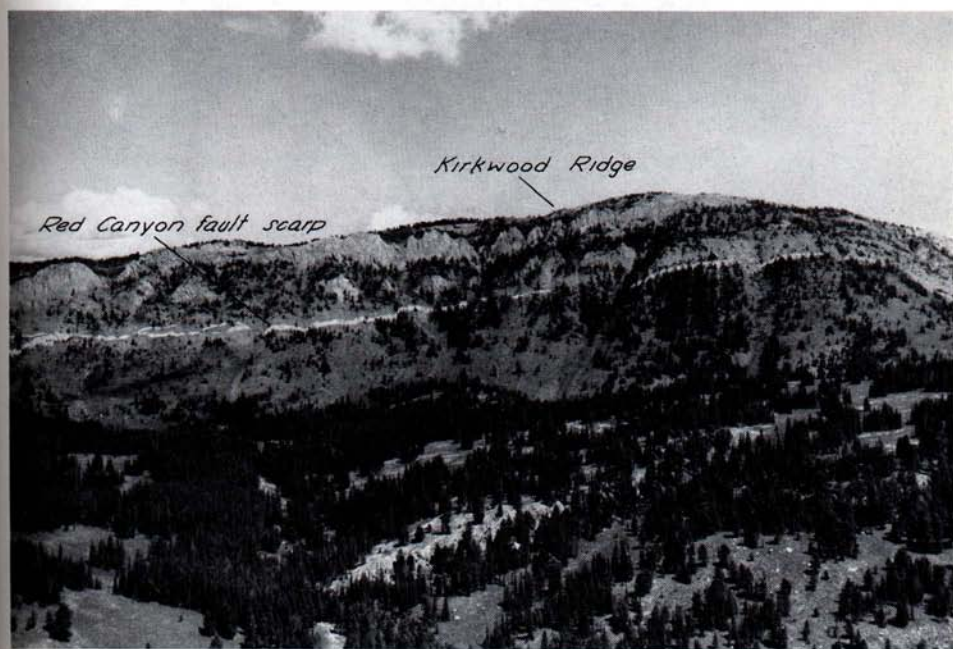
FIG. 2. Red Canyon fault scarp as exposed along south flank of Kirkwood Ridge.

Along the east wall of Red Canyon near its mouth, the fissure zone gives way to a single scarp, 6 feet high and dipping 55° SW. Northwestward, this scarp increases in height to about 10 feet, and locally 19 feet, and extends unbroken across Red Canyon Creek and along the south flank of Kirkwood Ridge (fig. 2). The scarp there curves to the southwest and decreases in height.

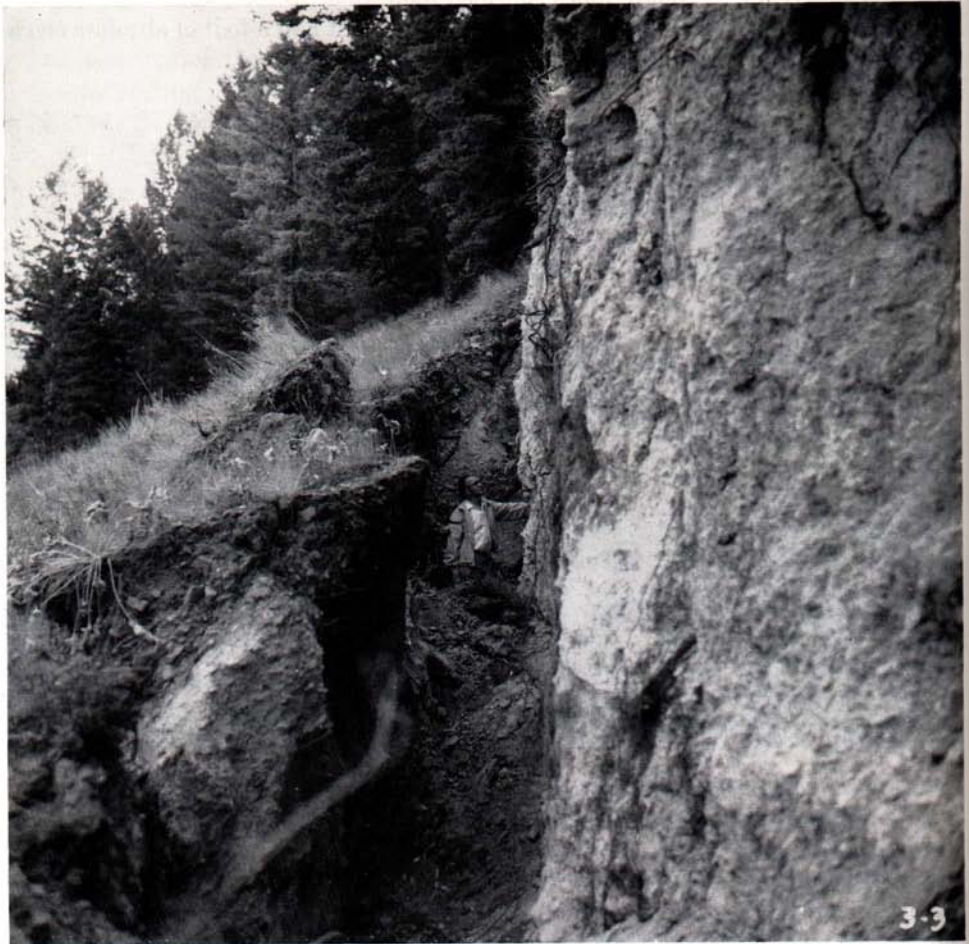
FIG. 3. Gap of a simple fault scarp as exposed along the trace of Hebgen fault near Kirkwood Canyon.

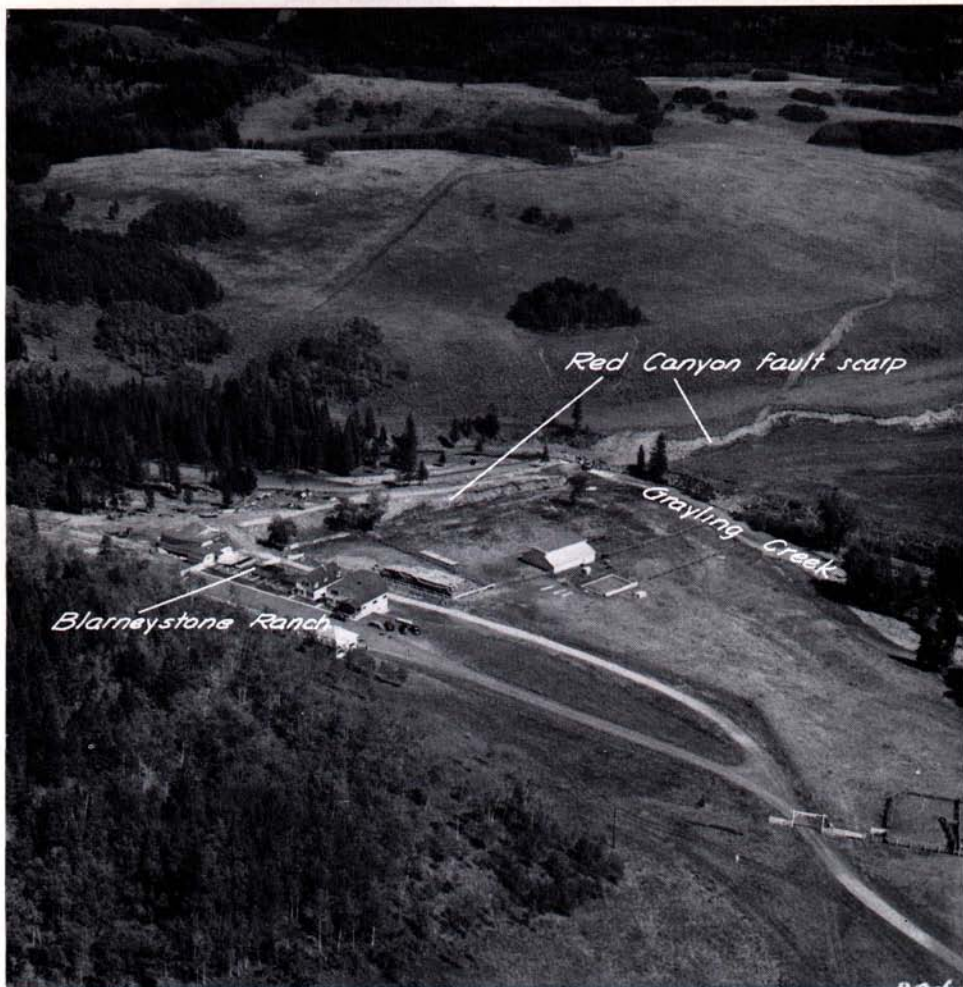
Red Canyon fault scarp.—The south-facing Red Canyon fault scarp (fig. 1) is about 14 miles long and as high as 19 feet near its midpoint. Near its southeastern end it is a series of small, gaping, discontinuous fractures. To the northwest, these fractures pass into small local scarps about 2 feet high along a low embankment formed during older movements. Both old and superimposed new structures increase in height toward U.S. Highways 287 and 191, which is offset by two parallel scarps. The northeastern scarp continues to the northwest, increasing in height gradually until it is about 14 feet high near Blarneystone Ranch, where at least two older episodes of faulting may be shown by higher, eroded scarps. The new scarp (fig. 4), superimposed upon one of the older ones, passes beneath the domestic quarters and storage sheds of the ranch, which were severely damaged by the earthquake.

FIG. 4. Aerial view looking northeast at Red Canyon fault scarp where it crosses the Blarneystone Ranch. The new scarp, about 14 feet high, passes beneath domestic quarters of the ranch.

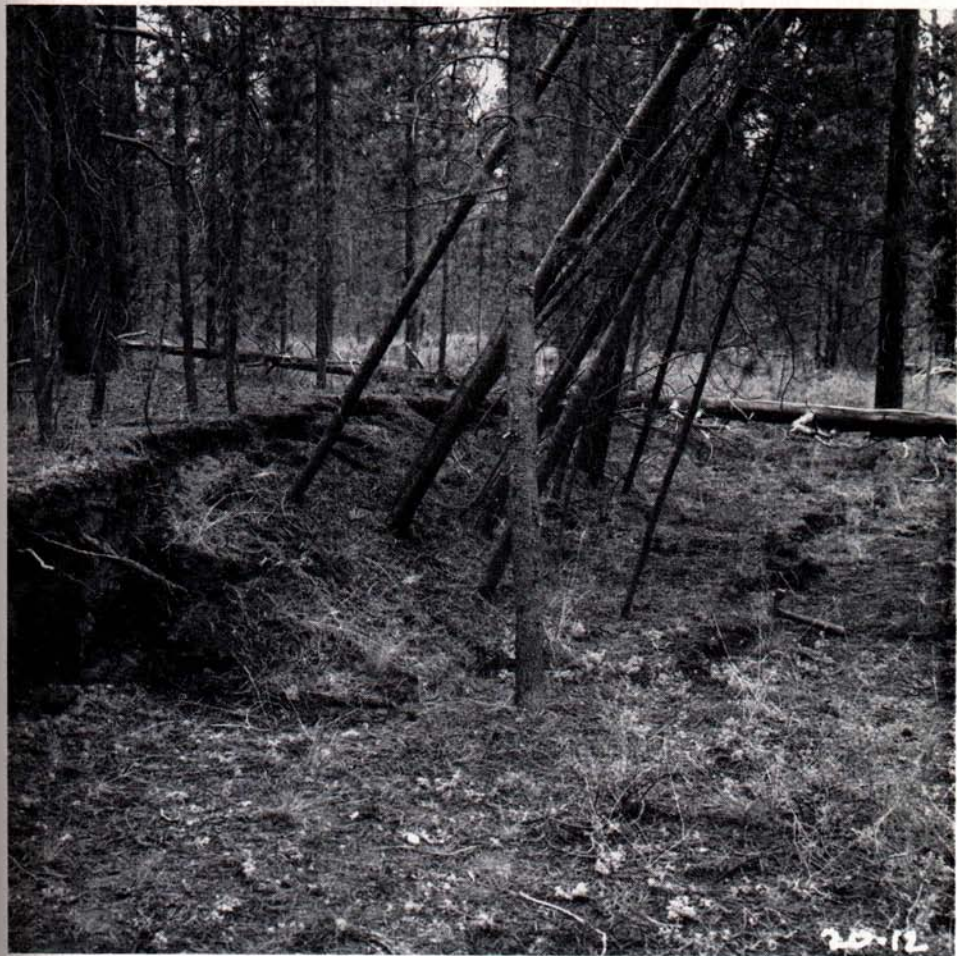
monocline is commonly broken by a nearly continuous miniature "mole-track" thrust fault which dips gently toward the larger structure at the surface but steepens downward. Such a fault is marked by the hammer in figure 5.

FIG. 5. New scarp and monocline in the sand plain. Fault, left, with tightly closed fissure, gives way to steep monocline, center, which gives way in turn to a gentle monocline.

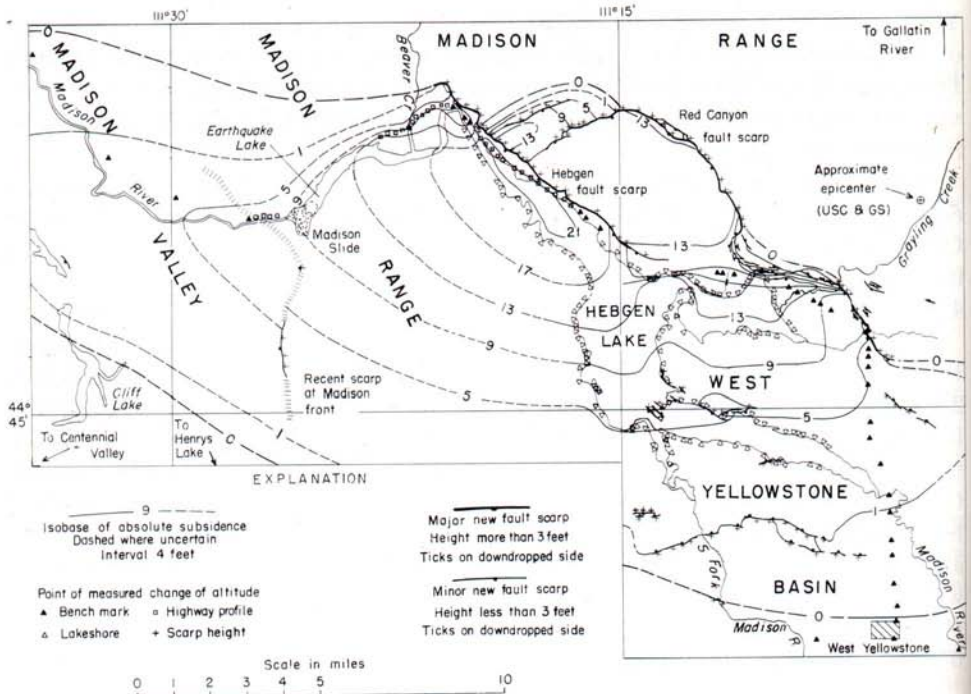
Myers and Hamilton picture a compound basin of new subsidence plunging gently eastward across the southern part of the Madison Valley and the Madison Range to Hebgen Lake, so that part of the range has subsided along with the bordering areas although to a lesser extent (fig. 6). This interpretation can be referred to as the "single-basin concept". The subsidence basin slopes gently on its southern flank,

FIG. 6. Isobase map illustrating the single-basin concept of ground deformation accompanying the Hebgen Lake earthquake.

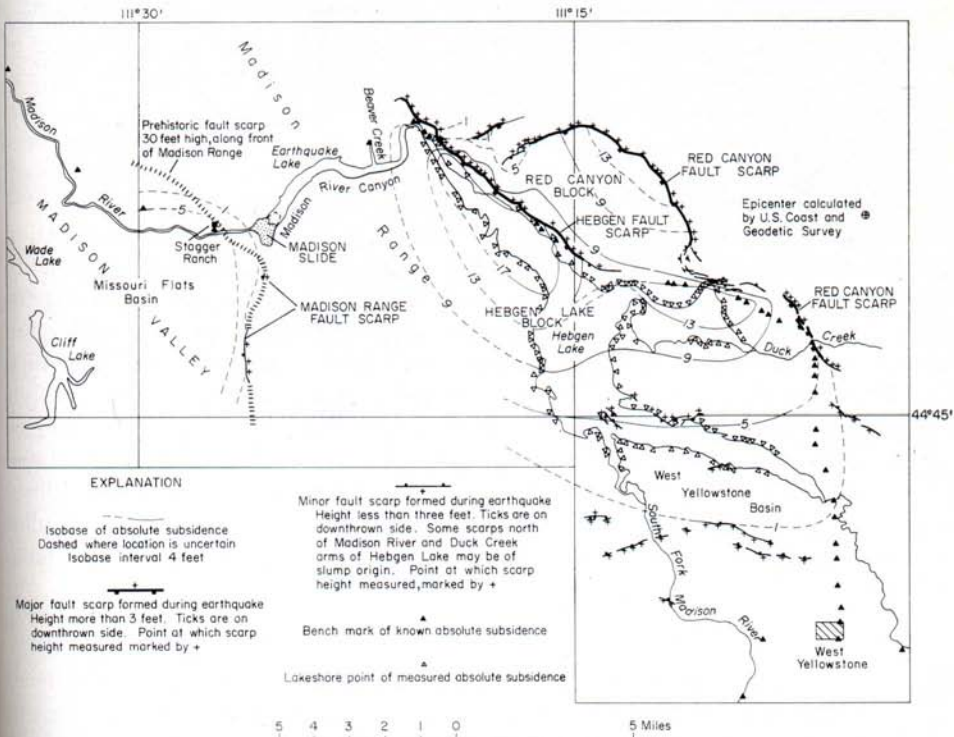
FIG. 7. Isobase map illustrating the fault-controlled dual-basin concept of deformation.

Witkind and Fraser make the interpretation, which can be termed the "dual-basin concept" (fig. 7), that the deformation was largely restricted to two fault-controlled basins on either side of the Madison Range, and that the crest of the

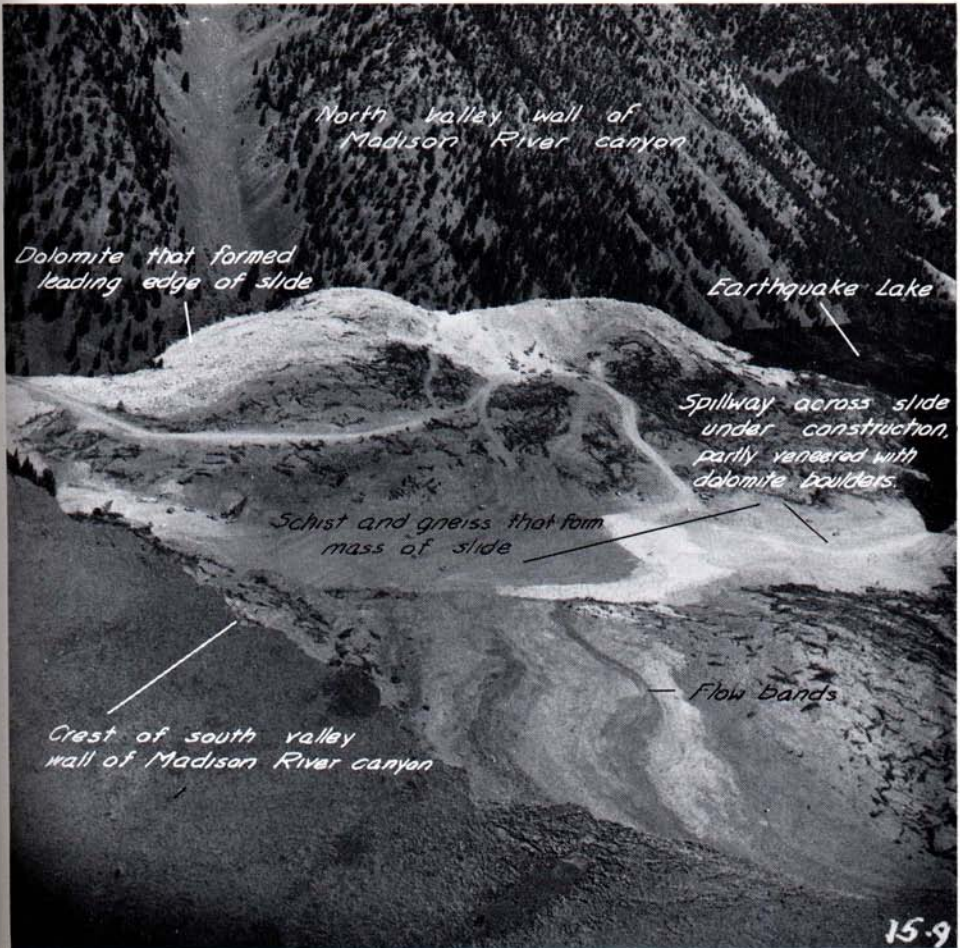
FIG. 8. Oblique aerial view looking N. 15° W. at the Madison Slide. Nearly a mile of the north wall of the Madison River Canyon is shown, as measured at the lowest exposed level.

A disastrous landslide was triggered by the earthquake in the canyon of the Madison River, 6 miles downstream from Hebgen Dam (fig. 8). Thirty-seven million cubic yards of broken rock slid into the canyon, burying a mile of the river and highway to depths as great as 220 feet. At least 26 people in a campground were buried by the slide, and many more people camping near the edge of the slide were injured. (Two other campers were killed by a rolling boulder at Cliff Lake, west of Madison Valley.) Water ponded by the slide formed Earthquake Lake, which

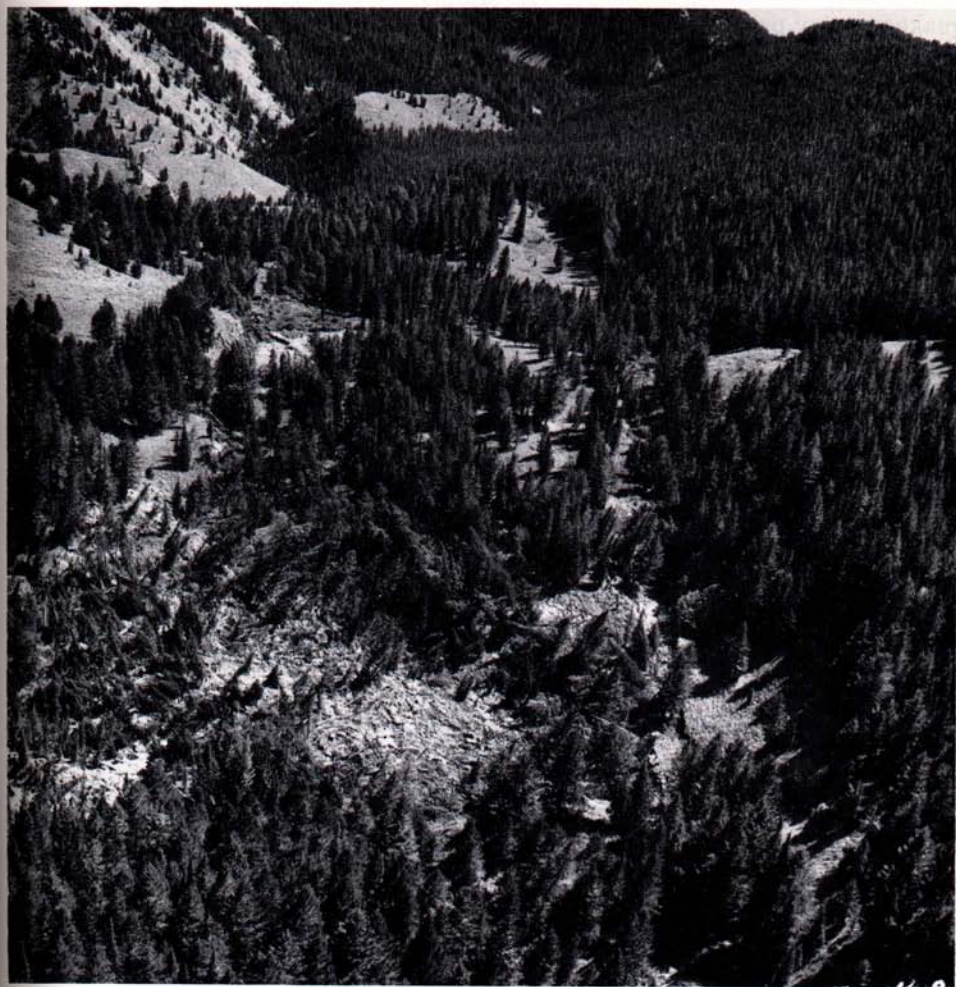
FIG. 9. Aerial view of the Kirkwood earthflow, Sept. 3, 1959, looking south in the direction of movement. The area of jumbled blocks and tilted trees in the foreground is near the head of the flow.
