Field Reconnaissance after the 25 April 2015 M 7.8 Gorkha Earthquake

by Stephen Angster, Eric J. Fielding, Steven Wesnousky, Ian Pierce, Deepak Chamlagain, Dipendra Gautam, Bishal Nath Upreti, Yasuhiro Kumahara, and Takashi Nakata

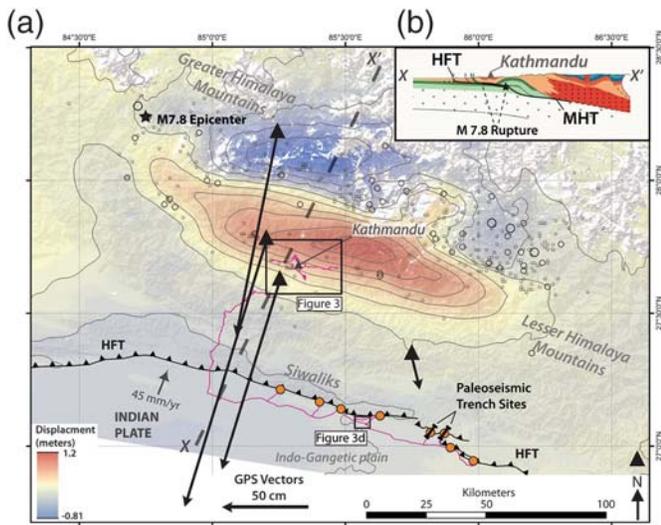
▲ **Figure 1.** (a) Overview map of Gorkha earthquake rupture region. The red (up) and blue (down) colors display line-of-sight motion measured from Advanced Land Observation Satellite 2 (ALOS-2) wide-swath Interferometric Synthetic Aperture Radar (InSAR) data, almost all due to vertical displacements. Contours are 20 cm of the InSAR motion. Global Positioning System (GPS) stations (black triangles) show horizontal motion. Aftershock distribution outlines approximate the extent of the fault rupture. Relative sizes of aftershocks ($M < 4$) are shown by open circles (National Seismological Centre of Nepal [NSCN], 2015; see [Data and Resources](#)). The pink lines show tracks of our reconnaissance work. The orange circles represent sites visited along the Himalayan frontal thrust (HFT). Paleoseismic trench sites of [Lave et al. \(2005\)](#) and [Sapkota et al. \(2013\)](#) are indicated on the map along the HFT. (b) The inset shows a general cross section across the plate boundary and approximate extent of the Gorkha earthquake rupture along the main Himalayan thrust (MHT). The generalized rupture area is indicated by the thick black line. The HFT is the active surface expression of the MHT.

InSAR interferograms of the epicentral region were constructed soon after the event and quickly posted to the Internet (e.g., [Lindsey et al., 2015](#); ARIA Center and Geospatial Authority of Japan [see [Data and Resources](#)]). Figure 1 shows the interferogram from a Japanese Aerospace Exploration Agency (JAXA) Advanced Land Observation Satellite-2 (ALOS-2) wide-swath (ScanSAR) interferogram on descending (west-looking) path 48, with data acquired on 21 February and 2 May 2015 and processed by the Caltech-Jet Propulsion Laboratory ARIA project (see [Data and Resources](#)). InSAR analysis was done with a modified version of the InSAR Scientific Computing Environment software ([Rosen et al., 2012](#) and Liang and Fielding, unpublished manuscript, 2015). The Global Positioning System (GPS) offset vectors in Figure 1 were also processed by the ARIA project (see [Data and Resources](#)).

Figures 1 and 3 show the sites visited along the HFT, previously mapped faults in southern Kathmandu Valley (Asahi, 2003), and suspected scarp features in the northern part of the valley (see Fig. 3). Our checks at each fault or lineament crossing included traverses along the faults and interviews of local inhabitants. At no locations did we observe or hear of ground ruptures along the respective fault lines.

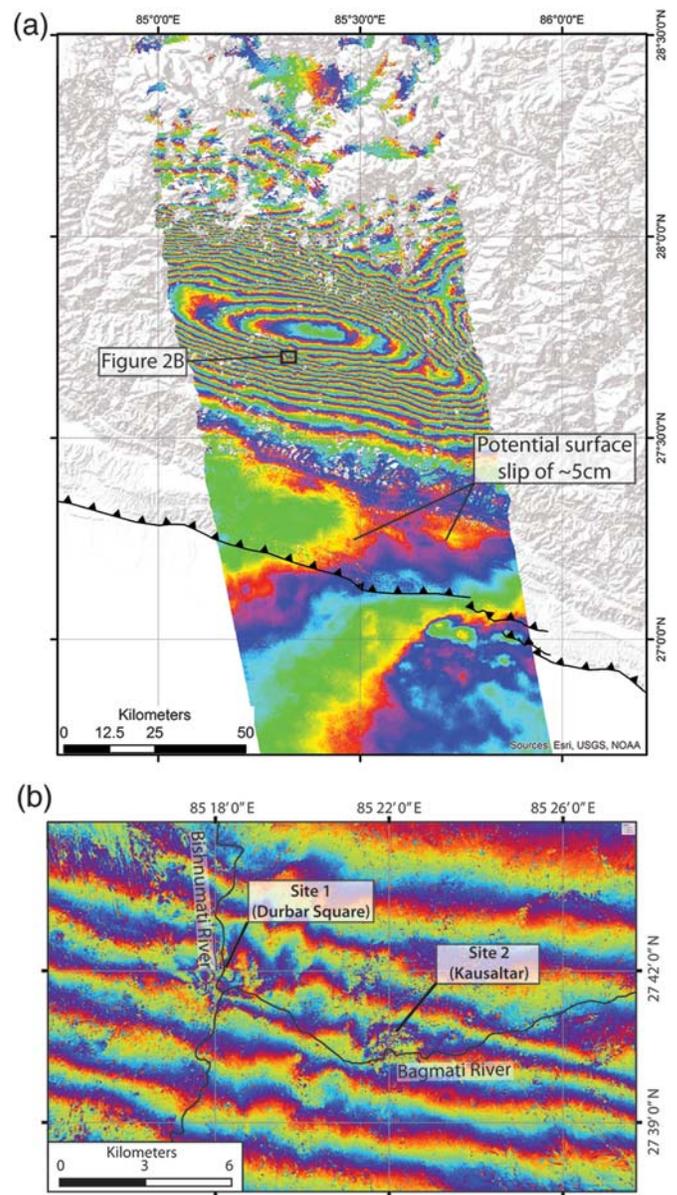
▲ **Figure 2.** (a) InSAR interferogram of the rupture region constructed from ALOS-2 fine-beam passes on 21 February 2015 and 2 May 2015. Each color fringe depicts 10 cm of displacement (slightly different from original ALOS-2 fringes). (b) Enlarged area of the fine-beam interferogram in Kathmandu showing the disturbance of fringes (each equivalent to 10 cm) that is consistent with a north-trending zone of ground deformation at site 1 and east-trending zone at site 2. The thin black lines show the trace of the Bagmati and Bishnumati rivers.

The interferogram of the region (shown in Fig. 2) was constructed from ALOS-2 ascending path 157 (east-looking) satellite passes on 21 February 2015 and 2 May 2015, bracketing the time of the mainshock. This interferogram is from ALOS-2 strip map beam SM3; it was processed with 8×16 looks (pixels averaged) in the range (across-track) and azimuth (along-track) directions (radar image postings of 80 m) and geocoded at a final pixel spacing of 30 m. Features down to ~100 m horizontal scale should be detectable. Each color fringe of Figure 2 depicts 10 cm of ground displacement in the radar line-of-sight direction, which varies from 34° to 39° from the vertical across the fine-beam swath. The wavelength of the ALOS-2 radar is 24 cm, so the original radar fringes indicate relative surface displacements of 12 cm per fringe. Surface displacements in these images

are generally represented by discontinuities in the contours. There are no major discontinuities at the scale of [Figure 2a](#). This interferogram, and those made by others, soon led to the interpretation that the earthquake rupture was confined to the sub-surface (e.g., [Berberian, 1995](#); [Yeats and Lillie, 1991](#)).

on a fault immediately north of the HFT between 27.242° N, 85.510° E and 27.241° N, 85.693° E ([Fig. 2a](#)). At that location, there is up to ~ 5 cm of slip at the surface in the radar line-of-sight but only on the very shallow part of the fault (less than ~ 500 m depth). This feature was also observed on a Sentinel-1 coseismic interferogram ([Fielding, et al., in preparation](#)) and confirmed with field observation in [Martin et al. \(2015\)](#).

The InSAR within Kathmandu Valley revealed minor interruption of interferogram fringes at two sites (Fig. 2b). The sites are labeled 1 and 2 in Figure 2b and located in the vicinity of Durbar Square and the community of Kausaltar. The disruption of fringes at site 1 trend approximately north–south and just to the east of the north-trending Bishnumati River, a tributary of the larger Bagmati. Our traverses through the area and queries with locals in the densely populated area un-

The disruptions in the interferogram fringes at site 2 (Fig. 2b) led us to a newly developed set of fractures that opened during the main earthquake, which caused significant damage to building structures and roads, ~1.5 km south-southeast of the Kathmandu International Airport (Fig. 3). We used large-scale Google Earth imagery and hand-held GPS units to locate and map the newly developed fractures in Kausaltar (Fig. 4). We also

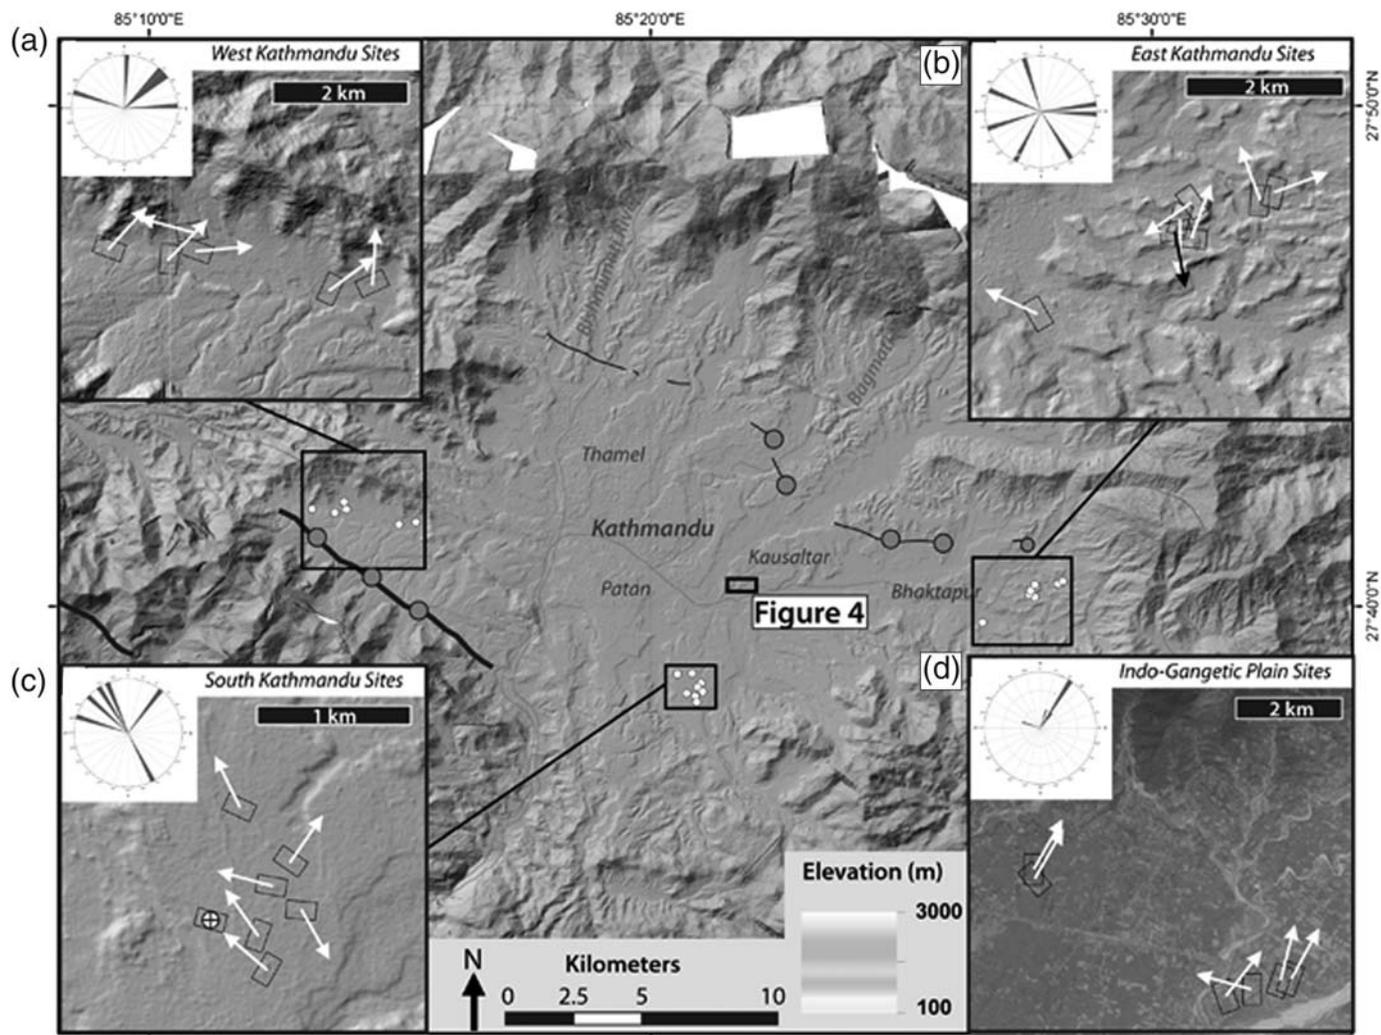
▲ **Figure 3.** Hillshade image of Kathmandu Valley developed from an 8 m digital elevation model (Noh *et al.*, 2015). The solid dots indicate sites traversed locally and queried local inhabitants. Thick black lines indicate previously mapped faults and thin black lines indicate newly defined lineaments. The inset corner figures are enlarged views of indicated areas displaying chimney data collected at the (a) east, (b) west, and (c) south Kathmandu Sites. (d) Chimney data from the Indo-Gangetic Plain are shown (see Fig. 1 for location). White arrows show fall direction from mainshock and black arrow shows fall direction resulting from large aftershock. © A color version of this figure is available in the electronic supplement as Figure S1.

generally range from European Macroseismic Scale (EMS) VII to VIII in Kathmandu Valley and EMS VI to VII along the HFT. The inset maps (a–d) of Figure 3 display the data collected at the four sites. The black rectangles represent the orientation of the kiln, and an arrow shows the chimney fall direction, summarized by rose plots in the upper left corners of each site (Fig. 3). We assume that the chimneys fell during the mainshock (white arrows), though in one case we were informed that failure occurred during the M 7.3 aftershock 16 days later (black arrow). White arrows show fall direction from mainshock and black arrow shows fall direction resulting from large aftershock.

The direction of chimney failure is not systematic when viewed across the four regions (Fig. 3). However, some consistency in fall directions is found when looking at each region individually. The azimuth of chimney falls at the west Kathmandu sites lie within the northeast quadrant in all but one case (Fig. 3a). Similarly, all but one of the chimney falls at south Kathmandu sites (Fig. 3c) near the southern edge of Kathmandu Valley align, in this case to the northwest. In contrast, chimney fall directions are essentially random in the area located at the east Kathmandu sites (Fig. 3b). The randomness of chimney falls in this region perhaps relates to its relatively more rugged topography as compared to the two prior regions. The remaining region is located just south of the HFT (Fig. 1) in the Indo-Gangetic Plain. Here, with one exception, the chimneys falls display a consistent northeasterly direction (Fig. 3d).

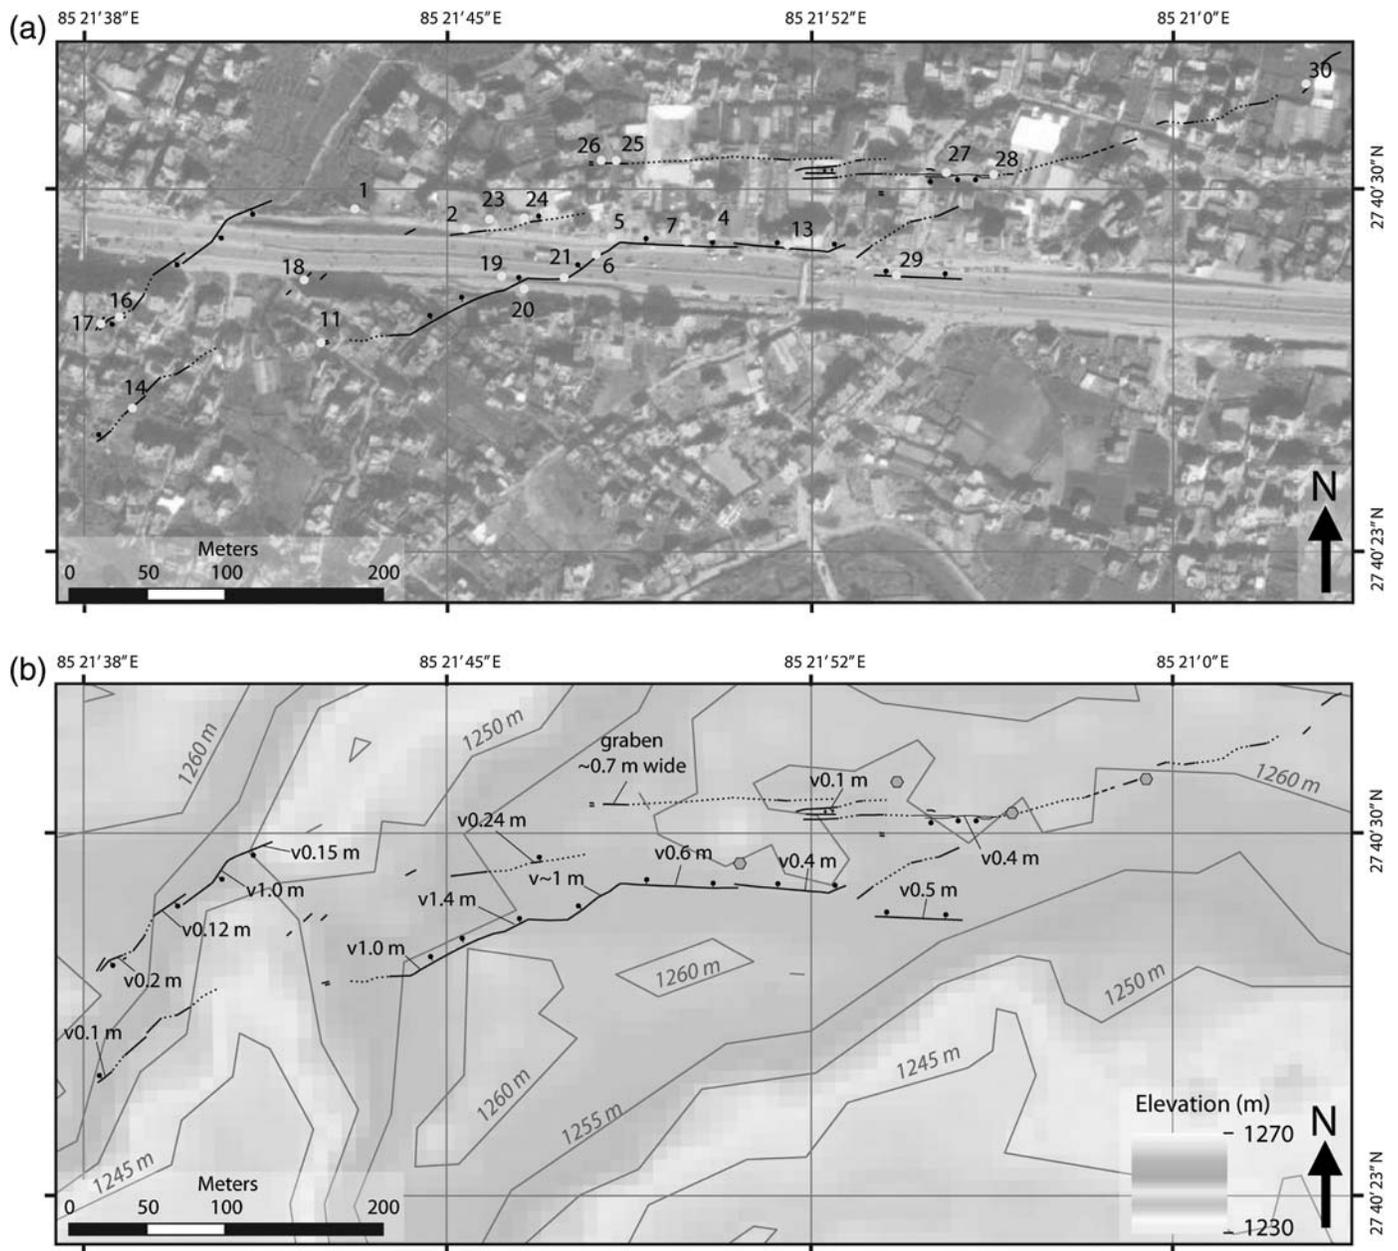
▲ **Figure 4.** (a) Locations of the northeast-trending Kausaltar fracture set. Black barbells show the downthrown side of each fracture. The solid dots show locations of associated photos in the [Ⓔ](#) electronic supplement. (b) Same-scale map of fractures and field measurements underlain by the hillshade image ([Noh et al., 2015](#)). Contours are at 5 m intervals. [Ⓔ](#) A color version of this figure is available in the electronic supplement as Figure S2.

collected vertical and horizontal offset measurements (Fig. 4b). In addition to the fractures, we mapped the location of four deep (~45 m) water wells within the mapped area (Fig. 4b).

The mapped fractures extend along a northeast trend for ~730 m, cutting across roads, small open fields, and building structures (Fig. 4a). A local resident observed some of these fractures opening ~30 s after the strong shaking from the mainshock (R. Bilham, personal comm., 2015). The fractures displayed 0.1–1.5 m vertical scarps facing both north-northwest and south-southeast, indicated with black barbells on the down-dropped side in Figure 4a,b. Horizontal extensions

A topographic analysis using an 8 m digital elevation model developed from DigitalGlobe imagery ([Noh et al., 2015](#)) shows that these fractures trend along a topographic high between two drainages (Fig. 4b). The four deep-water wells also trend along this topographic high, paralleling the fracture trend. The spatial association of the wells and fracture set is intriguing; however, structural mapping of the area and the well histories is needed to confirm a causal association but is unavailable.

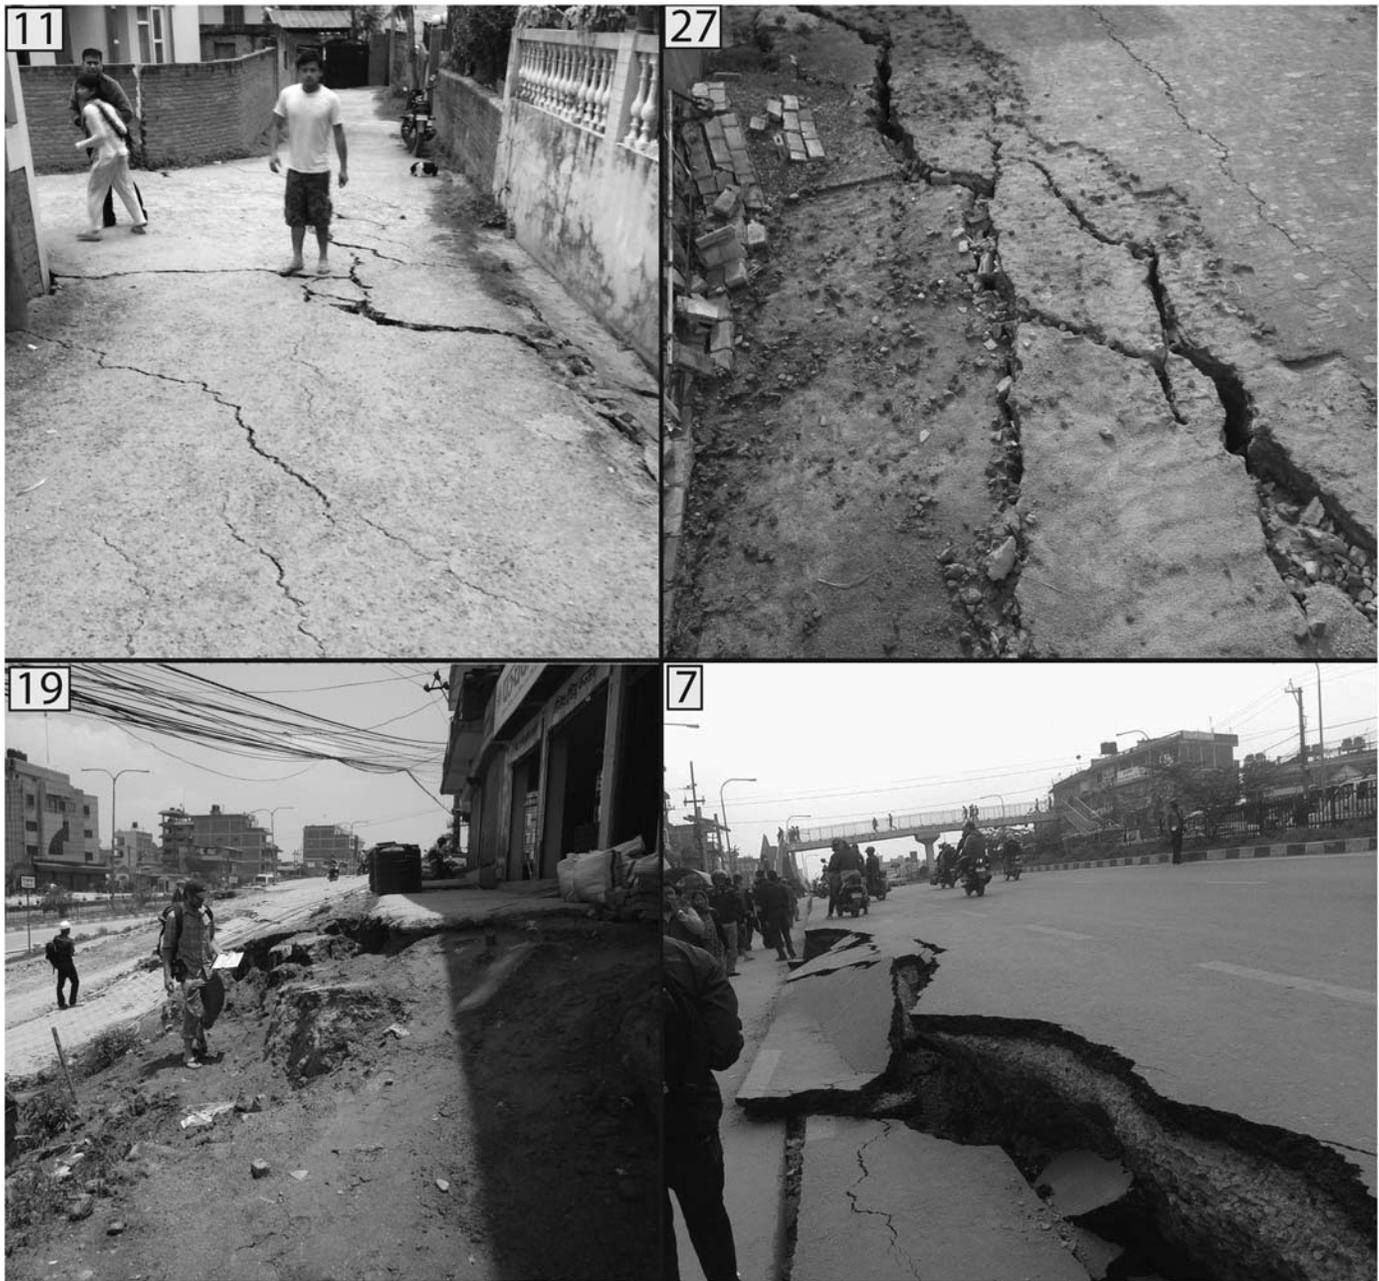
▲ **Figure 5.** Example photographs of the newly developed fracture set in Kausaltar. The number in the upper left corner gives the location number indexed to the map of shown in Figure 4a. Additional color photographs of Kausaltar fractures are provided in the (©) electronic supplement.

Bidirectional-facing scarps and the varied amount of horizontal extension across these fractures suggest that these are the result of local extension. Our observations limit net extension across the deformation zone to < 20 cm. Prior geophysical studies further indicate that there are no major basement structures underlying this portion of the Kathmandu Valley (Paudyal *et al.*, 2012). Together these observations suggest the zone of disturbance is not the result of deep-seated tectonic displacement, but rather cause by local site conditions and shaking.

Figure 5 illustrates the character of ground and building deformations. Locations of other photos along the trace taken soon after the event are indexed on the fault trace map of Figure 4a and are provided in the electronic supplement ((©) Figs. S3–S27).

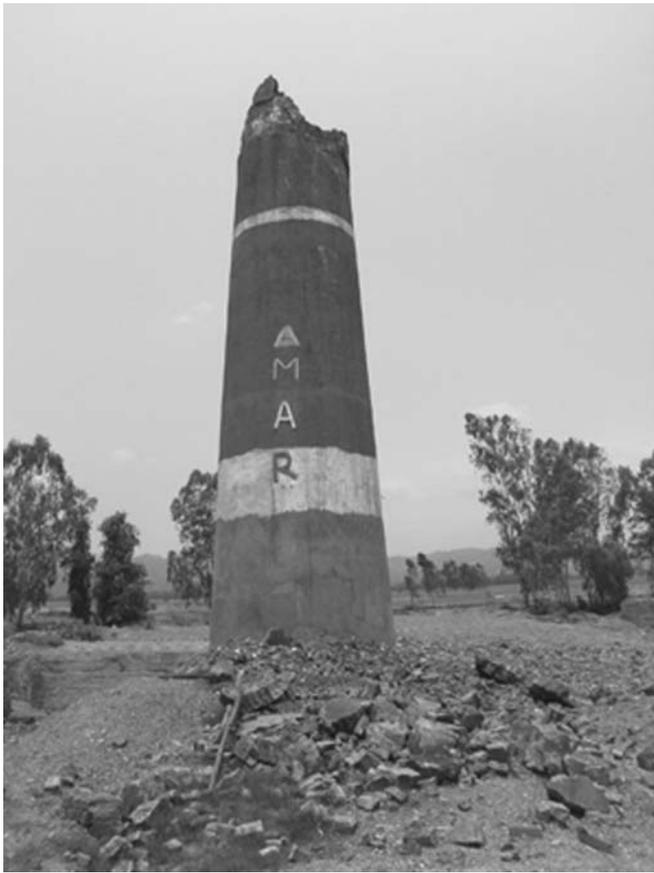
▲ **Figure 6.** Representative photo of a failed chimneystack located on the Indo-Gangetic Plain.

chimneystacks of the factories failed in a partial manner during the main earthquake. Failure of these chimneys generally resulted in toppling of the upper portion of the chimneys, leaving 10–30 m of the bottom part of the chimney remaining. A detailed engineering analysis of these failures is beyond the scope of this note, though the toppling characteristic appears in general accord with numerical analyses of chimney failures (e.g., Pallares *et al.*, 2011). The image of Figure 6 represents a common sight of a failed chimney.

The factories are set up on loam deposits in which bricks are excavated and cast onsite. The kilns are located onsite and laid out as 50–100 m long \times 25–40 m wide rectangles, each with a single 30–40 m tall, upwardly tapering, cylindrical chimney that has 5–7 m basal diameter (Fig. 6). Construction of the generally unreinforced brick masonry chimneys is documented more thoroughly in Bonapace and Sestini (2003).
